Brief communication: The northwest Himalaya towns slipping towards potential disaster

Abstract. The NW Himalaya (India) has been one of the most affected terrains of the Himalaya, subject to frequent disastrous landslides owing to active tectonics and multiple precipitation sources. This article focuses on two towns (Joshimath and Bhatwari) of Uttarakhand in the NW Himalaya, which have been witnessing subsidence for decades. Up until 9 January 2023, Joshimath had witnessed widespread cracks in more than 500 houses, which has prompted social unrest in the region. The hillslopes surrounding both towns comprise highly jointed gneisses with schistose interlayer rock mass. Both towns have subsidences and holes in the road, broken retaining walls, and displaced boulders, and the houses have cracks in the walls and holes. Recently, such slope instability phenomena have increased, which is leading to social movements in the region seeking government action such as possible evacuation and rehabilitation. The present study used a continuum-modelling-based slope stability simulation to determine the response of these hillslopes under various loading conditions: gravity, rainfall, building lo

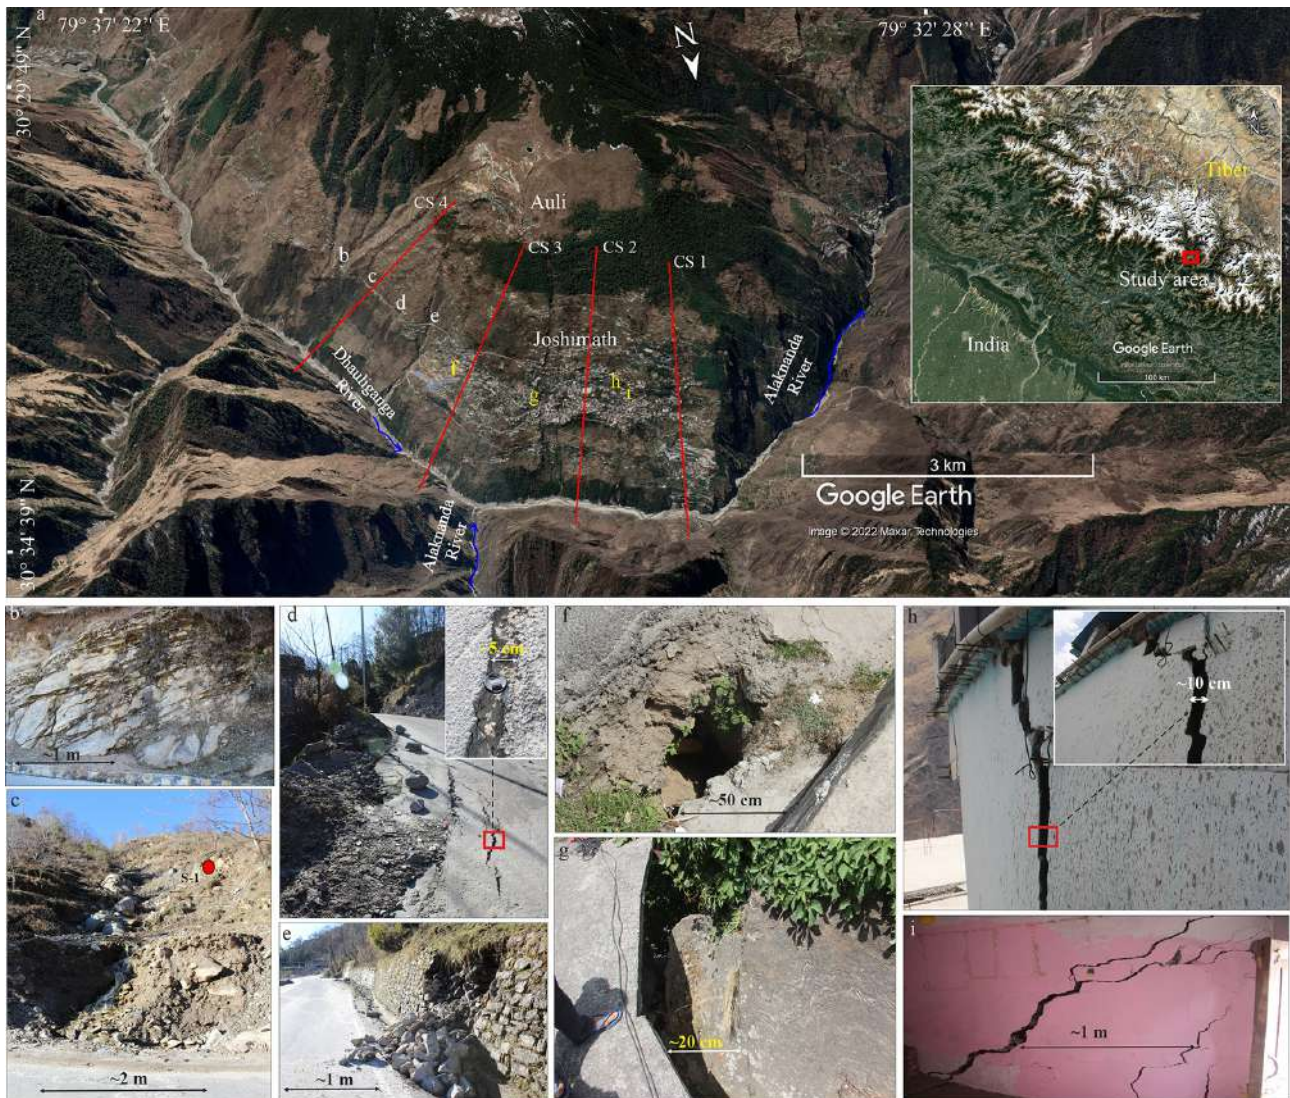
Figure 1. Field observation of Joshimath. (a) Location of Joshimath with the inset highlighting its position in the NW Himalaya. © Google Earth for panel (a). CS 1 to CS 4 mark the position of 2D slope sections used for the slope stability evaluation. (b) Rock mass exposure and (c) natural drainage (Nala) through the hillslope. Position of soil sampling site (S-1), (d) cracks and displacement in the road, (e) bulging and collapse of retaining wall, (f–g) displaced hillslope material and hence displaced pavements, and (h–i) cracks in houses. Picture (f–i) courtesy: Atul Sati.

to a hotspot, which is experiencing changing climate and rapid anthropogenic influence. Field observation of the town revealed that the hillslope of the town comprises highly jointed gneisses with schistose interlayer rock mass, and both towns have subsidences and holes in the road, broken retaining walls, and displaced boulders, and the houses have cracks in the walls and holes (Fig. 1). Loose hillslope material comprising sandy gravel soil (Fig. 1c), exposed on the eastern part of the town, points towards the possibility of a paleo-landslide on which most of the town is located. The last big earthquake (29 March 1999: M_w 6.6) occurred within a 26 km hypocentral distance from this town.

Details of slope configuration, material models, and input parameters is summarized in Supplement Annexure I. For both towns, four 2D slope sections (CS 1 to CS 4) were taken to minimize the uncertainty caused by subjectivity associated with a single slope section (Figs. 1, 2). A configuration model is shown in Supplement Fig. S4. Although the 3D slope stability could have been more informative, the subsurface regime is yet to be explored for a more comprehensive understanding.

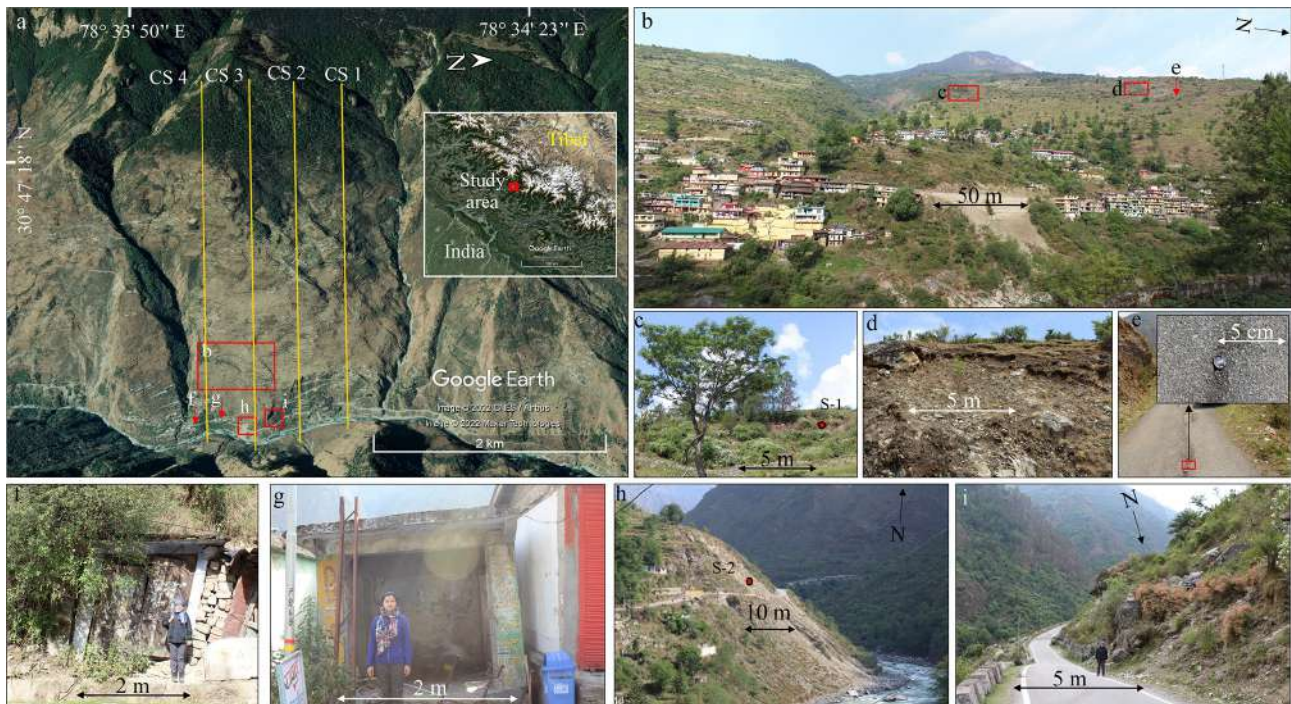
Figure 2. Field observation of Bhatwari. © Google Earth for panel (a). (a) Location of Bhatwari with the inset highlighting its position in the NW Himalaya. CS 1 to CS 4 mark the position of 2D slope sections used for the slope stability evaluation. (b–d) Exposed scarp. S-1 refers to the soil sampling site, (e) cracks and displacement of the road, (f–g) tilting houses and shops, (h) active slope failure at the slope toe, and (i) big gneissic boulder implying a paleo-landslide site.

Another town that is included in this article is Bhatwari (Fig. 2). As per the census (2011) of the government of India, it had a population of 1268 that is 1.0 % lower than that of the year 1991. Though the population migration from hilly terrains to plain areas is becoming a common phenomenon in the NW Himalaya owing to socioeconomic priorities, the decreasing human population of this town might also be due to such slope instability problems. Similar to Joshimath, Bhatwari is also situated along a narrow gorge incised by the Bhagirathi River Valley. The hillslope of the town comprises gneissic rock mass, and the MCT-I (locally termed the Vaikrita Thrust: VT) and MCT-II (locally termed the Munsyari Thrust: MT) faults pass through the northern and southern sides, respectively, of this region (Supplement Fig. S1). Two tributaries merging into the Bhagirathi River bound the hillslope from the northern and southern sides. Bhatwari is also situated on the orographic barrier setting and hence receives $1063 \pm 124 \text{ mm yr}^{-1}$ avg annual (years 2000–2021) rainfall (Supplement Fig. S2). Field observation revealed exposed scarps in the upper part of the town, cracks in the road, and tilting houses (Fig. 2b–g). Big (1.2–1.5 m) boulders and active slope failure in the loose material at the slope toe indicate the possibility of a paleo-landslide on which Bhatwari is located (Fig. 2h–i). Yadav et al. (2020) have also noted the material displacement in the range of $12\text{--}22 \text{ mm yr}^{-1}$ during the years 2006–2016 at this location. The last big earthquakes

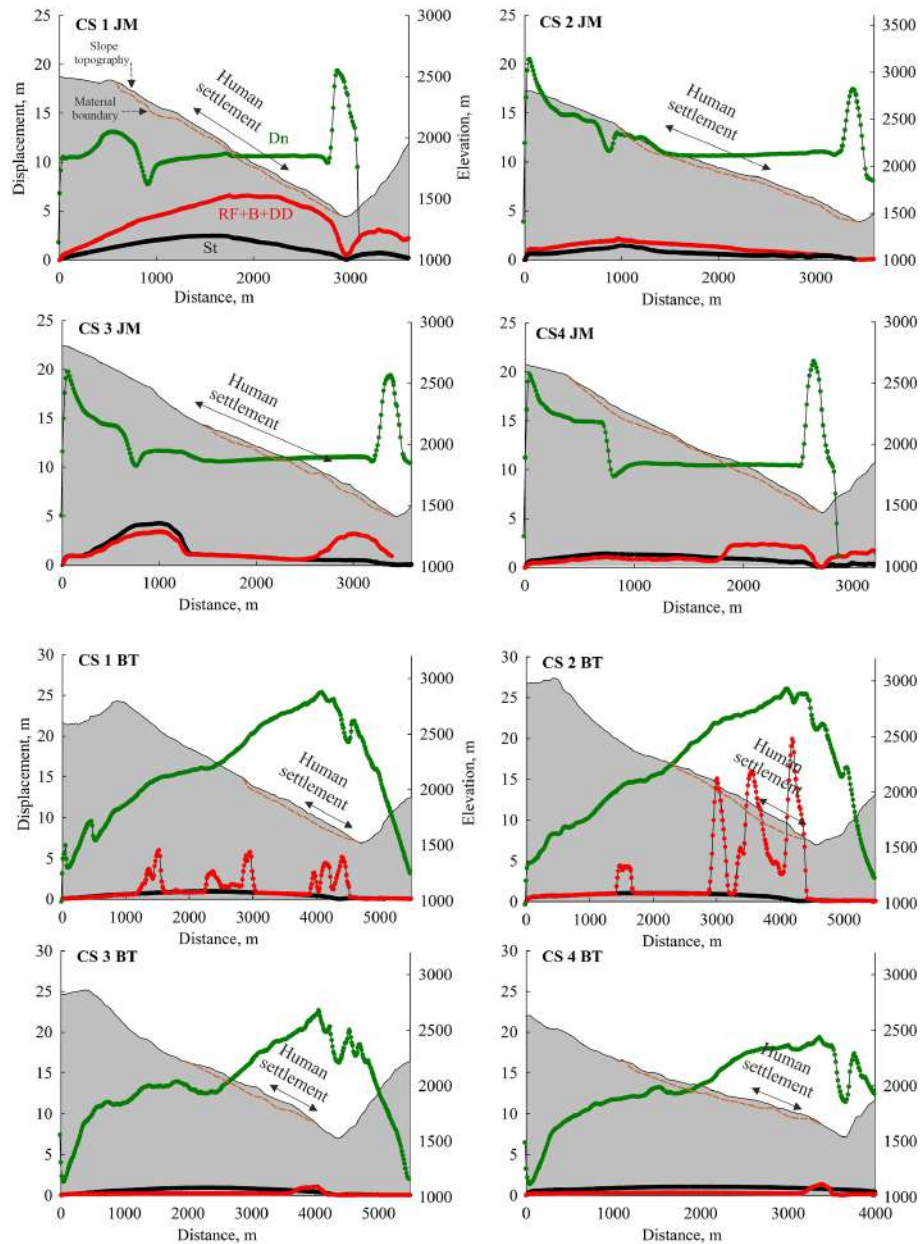
Figure 3. Results of the slope stability evaluation. CS 1 JM to CS 4 JM refer to Joshimath slope sections, whereas CS 1 BT to CS 4 BT refer to slope sections of the Bhatwari hillslope. Dn, RF, B, DD, and St refer to dynamic, rainfall infiltration, building load, domestic discharge, and static load, respectively.

Stability evaluation results for both locations are discussed using the total (horizontal and vertical component) displacement in the top 5–10 m material layer along the slope surface. If horizontal and vertical displacements refer to “ x ” and “ y ”, the total displacement is equivalent to $\sqrt{(x^2 + y^2)}$. Displacement profiles for Joshimath revealed that the slope may yield a 1–4 m displacement under gravity load conditions. This gravity (or static) condition also refers to the equilibrium state. The gravity-caused displacement might increase by up to ~ 6 m under the combined effect of rainfall (RF) infiltration, building/house load (B), and domestic discharge (DD)

(Fig. 3). In Fig. 3, JM and BT refer to Joshimath and Bhatwari, respectively. The CS 1 and CS 3 sections of Joshimath yield relatively higher displacement under these loads, particularly near the slope toe. Under seismic load conditions, displacement increases rapidly in the range of 8–22 m, particularly at the knickpoints of the slope surface and near the slope toe. Relatively higher seismic displacement at the slope toe is attributed to stress accumulation at the slope toe and a narrow geomorphic setting, resulting in constructive seismic interference, as also noted in other case studies involving earthquake-induced landslides (Meunier et al., 2008). Notably, the slope crest region comprises a debris layer that must have affected topographic amplification and hence the relatively lower displacement, as also noted in a recent study in the SE Carpathians (Kumar et al., 2021a).

Similarly to the Joshimath hillslope, displacement profiles for the Bhatwari hillslope show dominance of higher displacement (up to ~ 25 m) at the slope toe under seismic load conditions (Fig. 3). Notably, under the combined effect of rainfall, domestic discharge, and building load, the CS 1 and CS 2 sections of the Bhatwari slope comprise pockets of higher displacement (5–20 m), particularly near the slope toe. This could be attributed to a thicker debris deposit and a cluster of human settlement at the location of these slope sections (CS 1 and CS 2).
